HOUSATONIC RIVER BASIN
WASHINGTON, MASSACHUSETTS

ASHLEY LAKE DAM
MA 00313

PHASE I INSPECTION REPORT
NATIONAL DAM INSPECTION PROGRAM

FEBRUARY 1980

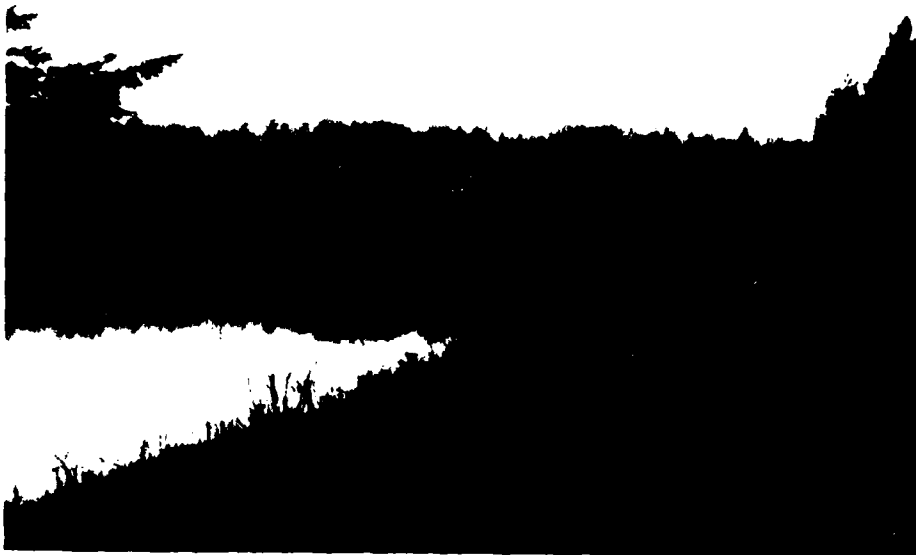
Photo 1 - Dam overview
looking northwesterly
from right abutment.

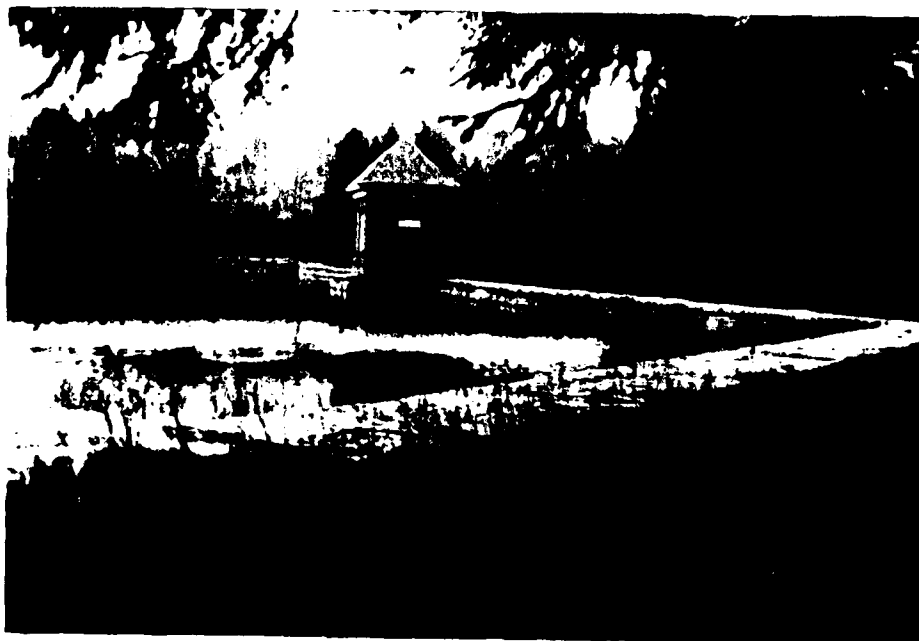
Photo 3 - Dam overview
looking westerly from
right embankment.

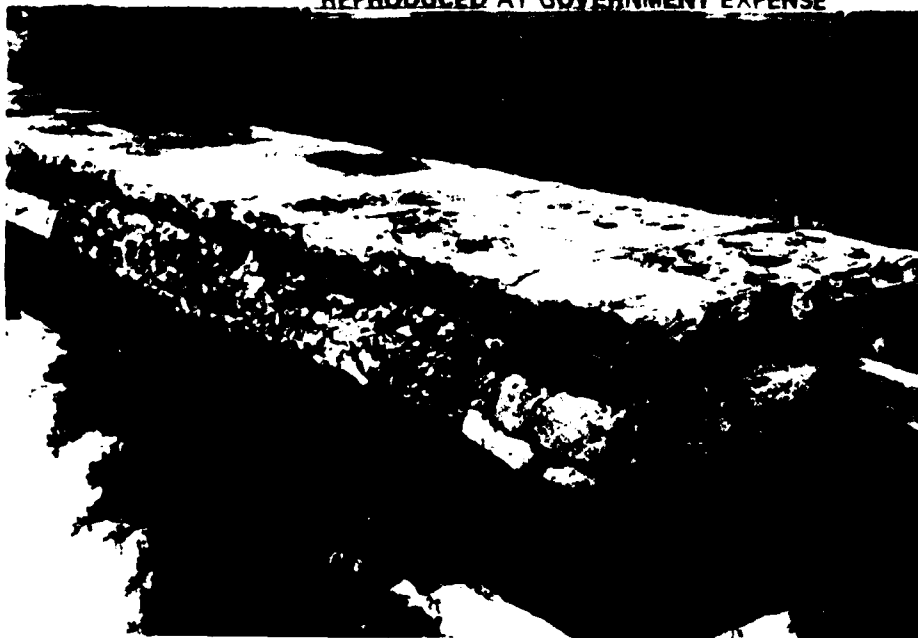
Photo 7 - Looking northerly at upstream face of dam left of spillway.

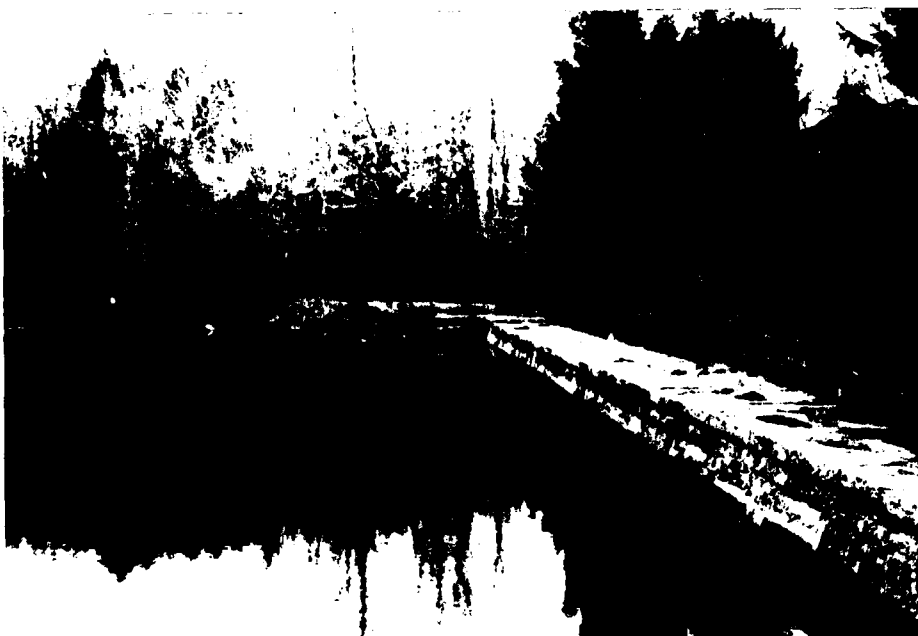
Photo 8 - Upstream face of dam looking westerly from gate house.

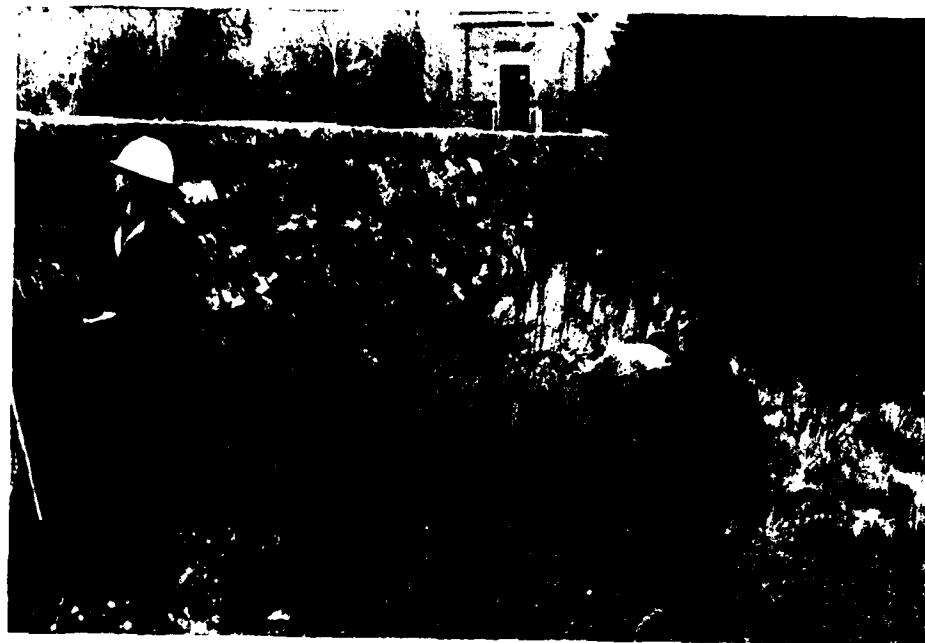
Photo 11 - Wet area at
toe of slope looking
northerly from dam.
